**RE: 505 1st Street, Milford, Nebraska  
City Hall**

Pursuant to your request, Structural Design Group performed a visual observation of the aforementioned property on July 10, 2006. The purpose of the observation was to determine the reasons for the noticeable settlement near the front vault area and provide an overall observation of the existing building structure. Destructive examination and the observation of the roof framing or members were not within the scope of services.

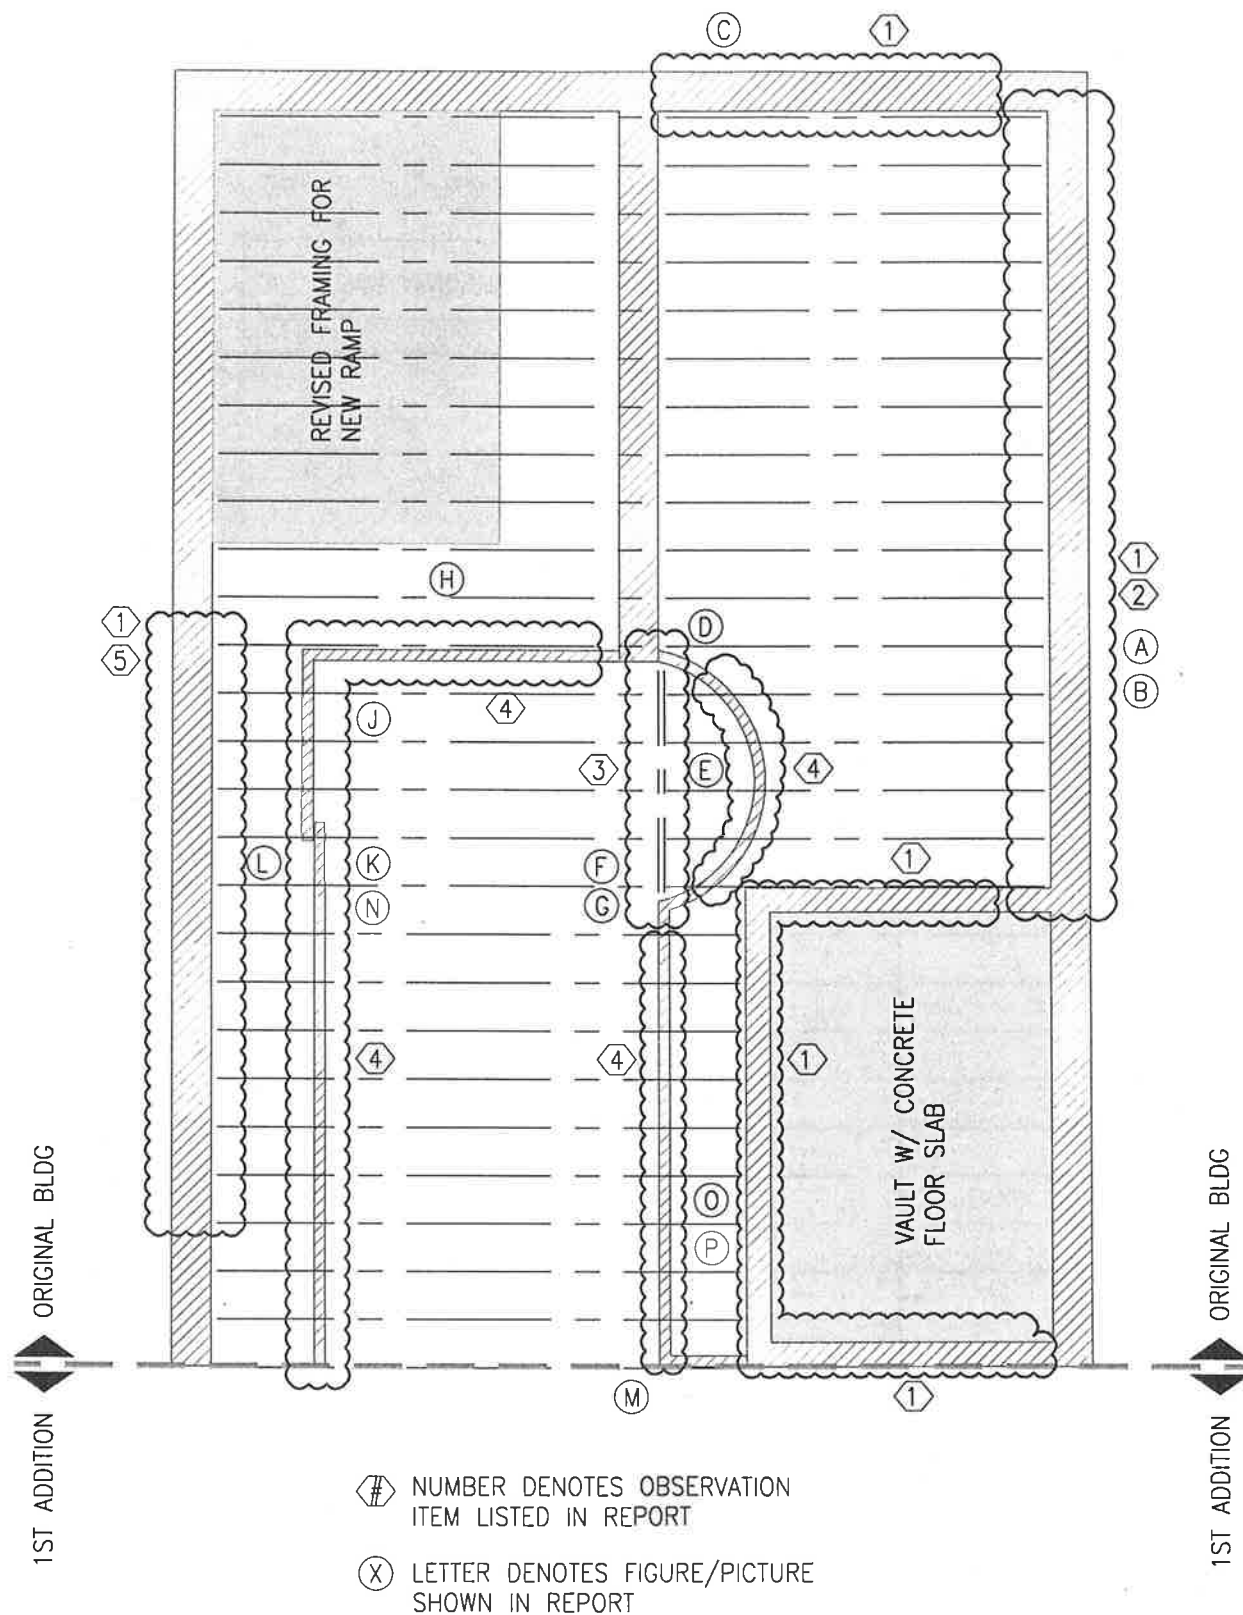
Original Building

The single wythe brick wall that forms the perimeter of the partial basement under the original building is failing with multiple cracks throughout the wall and horizontal movement at the top of the wall. It is currently acting as a retaining wall, but it has no capacity to resist the loads imparted on it. There does not appear to be any type of foundation under this other than the concrete slab-on-grade floor system.

A portion of what appears to be the footing of the west exterior wall is visible and it is located above the single width brick retaining wall. This creates a substantial lateral load on the wall that it is not designed to resist. Again, through this exposed area, efflorescence is visible and the deterioration of the wall is evident based on the build up of mortar and brick remnants at the base of the wall.

If the partial basement in the original building is to be kept, the existing single width masonry wall should be removed and replaced with reinforced cast-in-place concrete or concrete masonry unit walls. Either option shall be designed according to required lateral pressures taking into account the possible adjacent footing loads that are occurring.
